Manhole Inspection Summary

Manhole # S35GG1007MH

Insp Date: 1/30/07 7:43 AM

Location Address: **3811 ST PAUL ST**

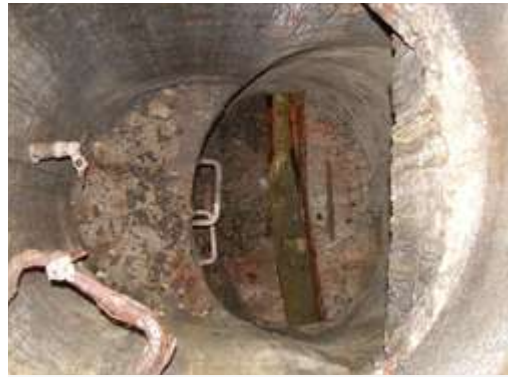
Top View

Corroded and missing steps. Bench and Channel debris.

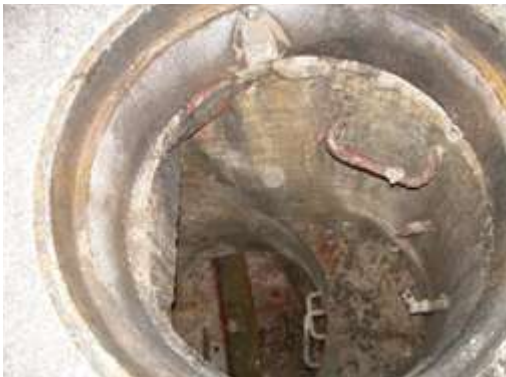
Defect

Frame leaks. Adjustment deterioration and infiltration. Barrel infiltration.

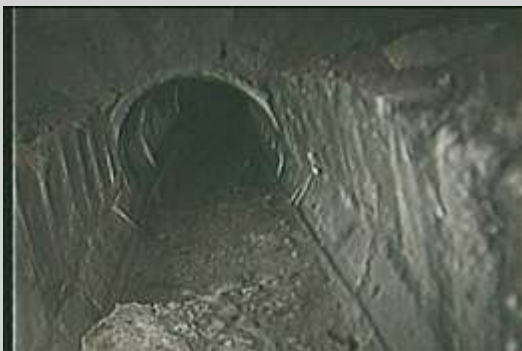
8 in. Circular Gravity Sewer Pipe In @ 5 O'Clock

Channel deterioration.

Deposits: ☐ None ☒ **Mud** ☐ Sludge ☒ **Debris** ☐ Grease

Silt Depth: **1** (in.) Deposits Extent: **Light**
